FINAL RANDOM INSPECTION / PRE-SHIPMENT INSPECTION

# COMPREHENSIVE SAMPLE QUALITY INSPECTION REPORT

Bamboo-Covered Stainless-Steel Vacuum Cup

| SAMPLE REPORT NO. | CP-SAMPLE-PSI-001 |

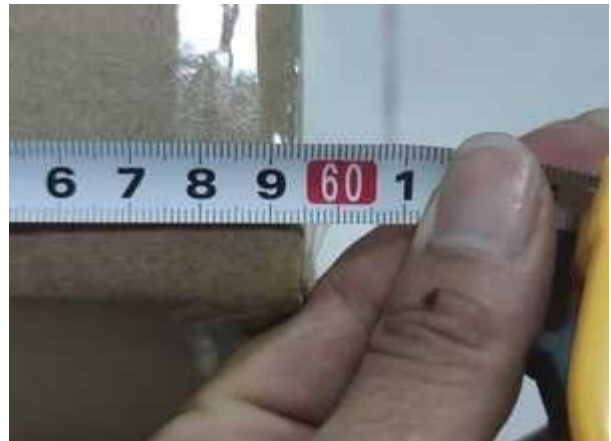
**P-012** Master-carton size 59.5 x 40 x 28 cm (2/2)

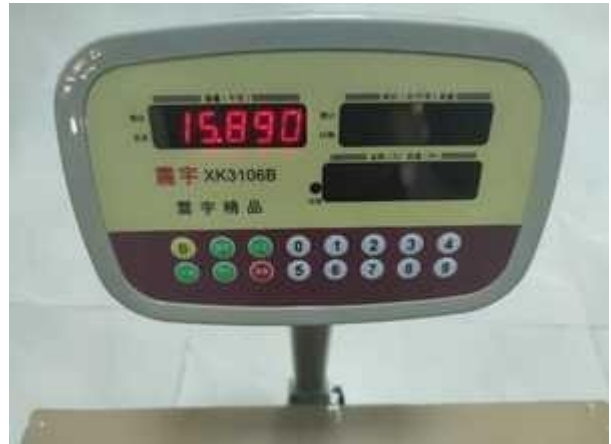
**P-014 Gross weight 15.89 kg (2/2)**  
Original source report page 5 of 26

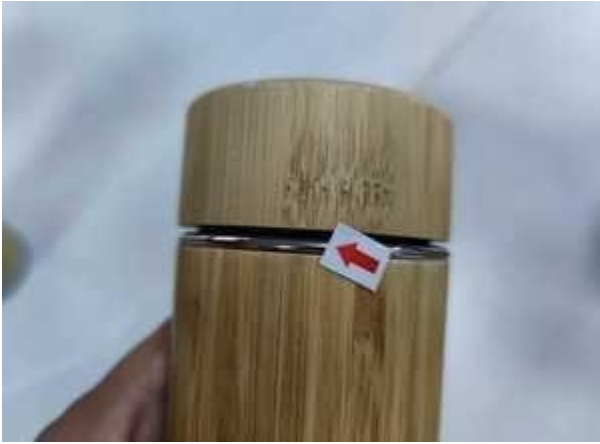
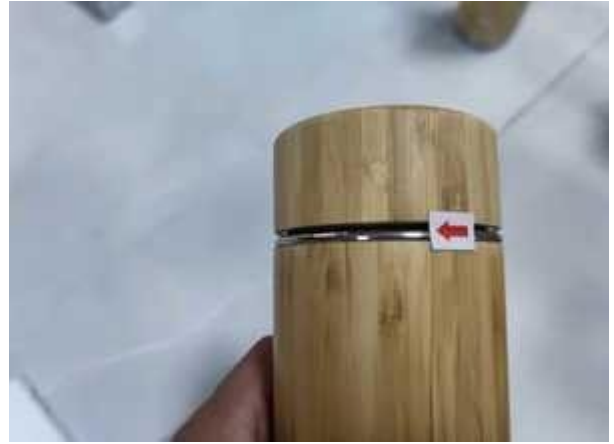
**P-045 Oversized visible gap - minor - 3 pcs (1/3)**  
Original source report page 12 of 26

**P-046 Oversized visible gap - minor - 3 pcs (2/3)**  
Original source report page 12 of 26

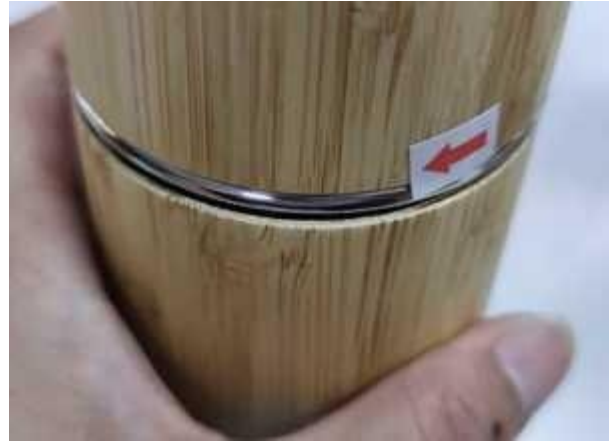
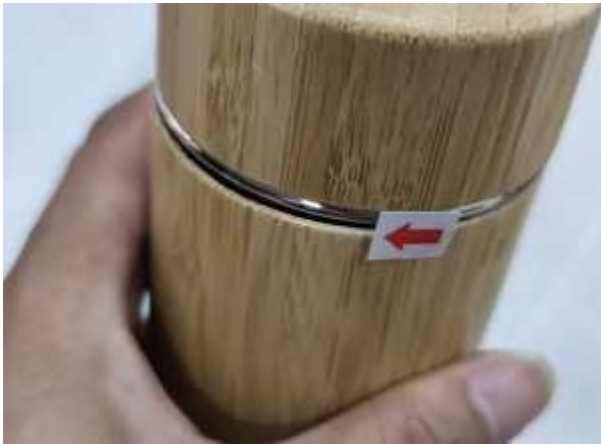
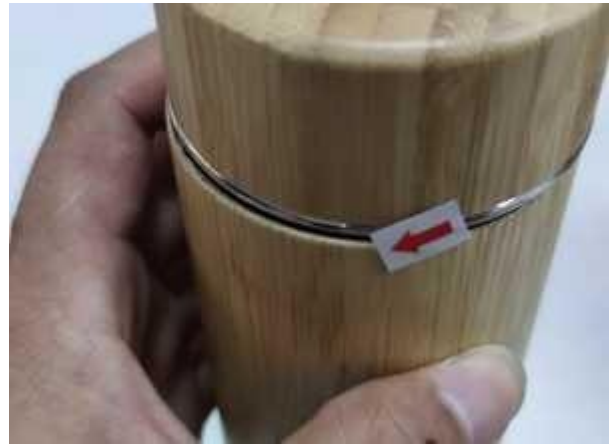
| Finding | Count | Potential cause | Containment | Verification |
|---|---|---|---|---|
| Major fit / seating gap | 3 | Tolerance stack-up, lid mismatch or assembly variation | Sort lid/body fit and identify affected variant | Additional random closure and leakage test |

**Functional linkage:** A visible gap may be cosmetic or functional. It becomes major when closure seating, leakage performance or saleability is materially affected.

**P-048 Major fit / seating gap - 3 pcs (1/3)**  
Original source report page 12 of 26

**P-049 Major fit / seating gap - 3 pcs (2/3)**

**P-050 Major fit / seating gap - 3 pcs (3/3)**

**Reinspection trigger:** If the defect is systemic or the supplier changes parts, a new random sample should be drawn after rework.

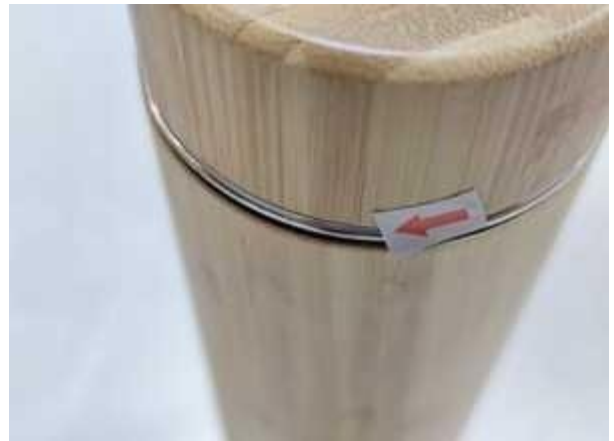
**P-052 Localized clearance gap - minor - 2 pcs (2/2)**

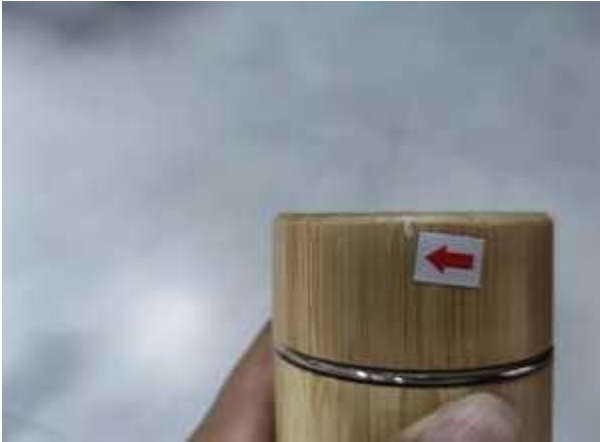
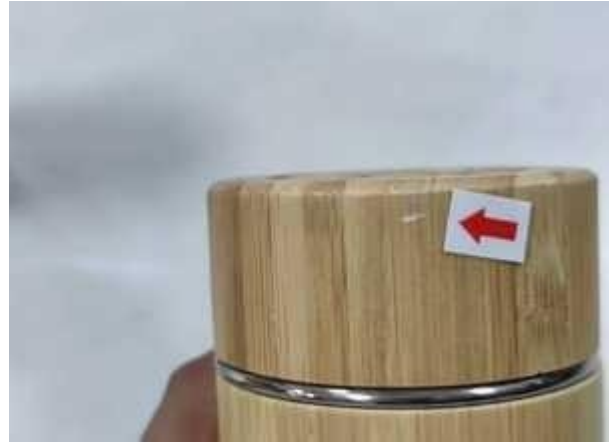
**P-053** Scratch mark - minor - 2 pcs (1/2)  
*Original source report page 13 of 26*

**P-054** Scratch mark - minor - 2 pcs (2/2)  
*Original source report page 13 of 26*

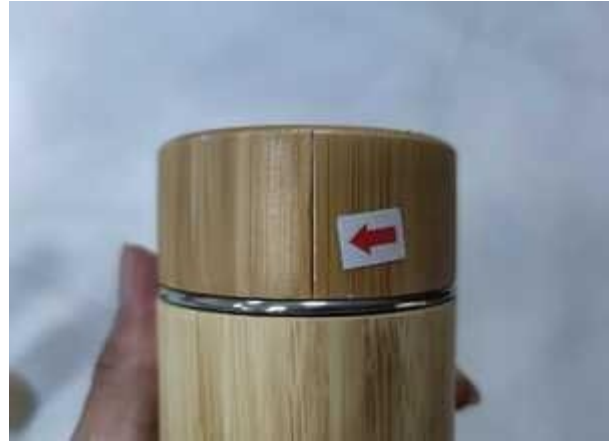
| Defect ID | Normalized description | Critical | Major | Minor | Photo range |
|---|---|---|---|---|---|
| D-01 | Crack mark | 0 | 1 | 0 | P-056 |

| Finding | Count | Potential cause | Containment | Verification |
|---|---|---|---|---|
| Crack mark | 1 | Bamboo sleeve stress, handling damage or poor incoming material | Segregate damaged unit and inspect adjacent production | Focused crack check after rework |

**P-056** Crack mark - major - 1 pc  
*Original source report page 13 of 26*

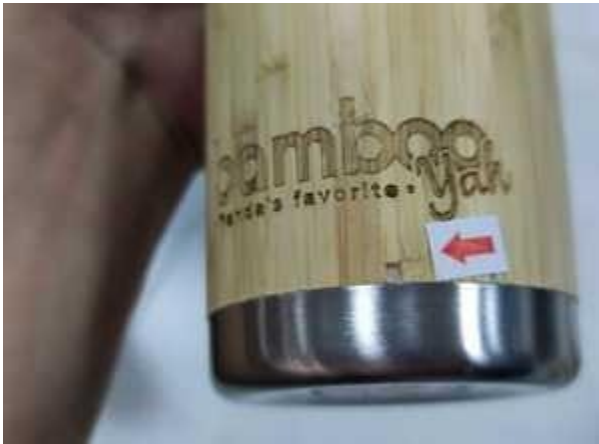
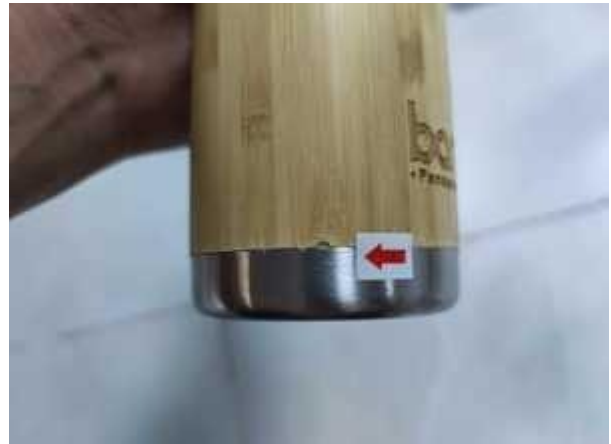
| Defect ID | Normalized description | Critical | Major | Minor | Photo range |
|---|---|---|---|---|---|
| D-02 | Broken / chipped area | 0 | 0 | 2 | P-057 to P-058 |

| Finding | Count | Customer impact | Recommended control |
|---|---|---|---|
| Broken / chipped area | 2 | Visible finish damage and lower perceived quality | 100% visual sorting of bamboo sleeves and edges |

**P-057 Broken / chipped area - minor - 2 pcs (1/2)**

**P-058 Broken / chipped area - minor - 2 pcs (2/2)**

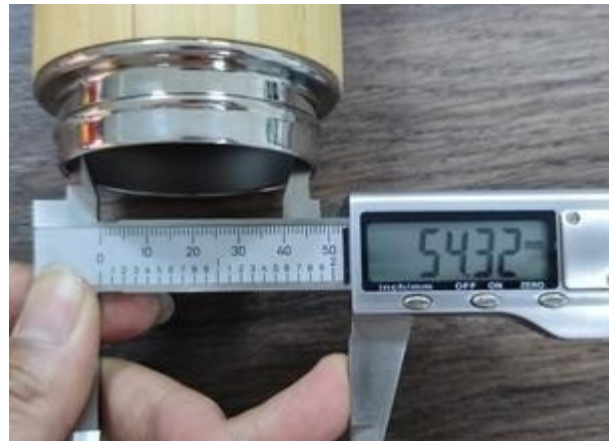
**P-068** Inside opening diameter 54.32 mm  
Original source report page 16 of 26

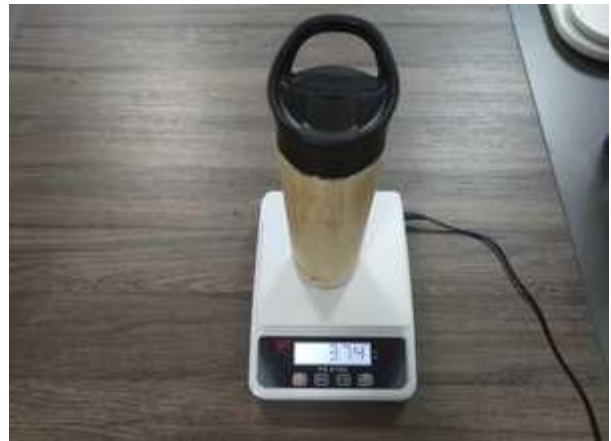
**P-072** Product weight 374 g

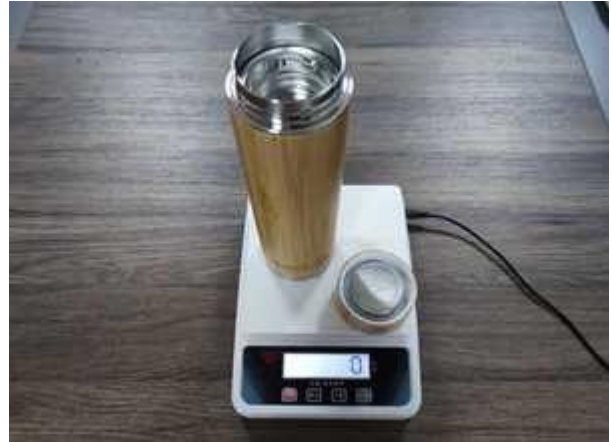
**P-074 Usable-capacity check - 1 pc - 480 ml - PASS (1/2)**

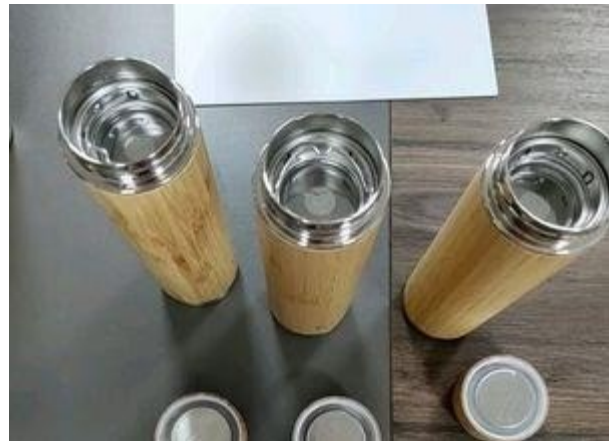
**P-076 Airtight test - 6 pcs - PASS**

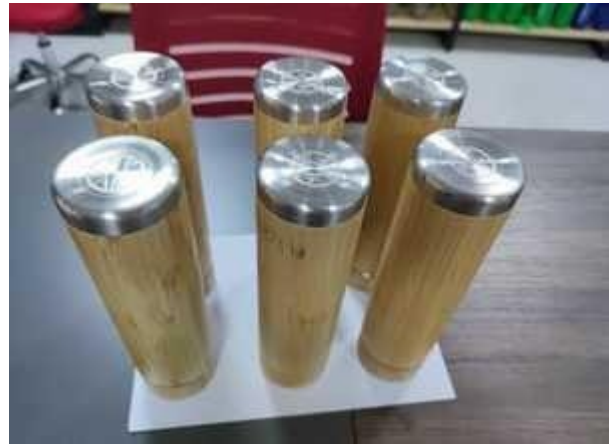
| Test | Quantity | Acceptance criterion | Recorded result | Decision |
|---|---|---|---|---|
| Airtight / leakage | 11 pcs | No visible leakage during defined field test | 11 passed | PASS |

**P-078** Airtight test - 11 pcs - PASS (2/4)

| RELEASE ACTION | Repeat targeted leakage testing after any lid-fit rework |

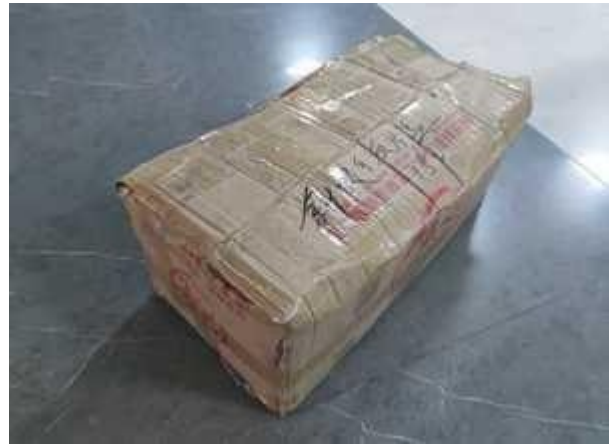
| Control | Observed | Risk | Required closure |
|---|---|---|---|
| Accessory-lid boxes | Poor condition; three different sizes | Damage, mixed packing, inconsistent presentation | Use one approved box specification |

**P-118** Accessory-lid outer boxes - poor condition, Chinese characters and three sizes  
*Original source report page 26 of 26*

| Open point | Current evidence | Client / supplier decision | Release status |
|---|---|---|---|
| Accessory-box quality | Photo P-118 | Replace / standardize three box sizes | OPEN |

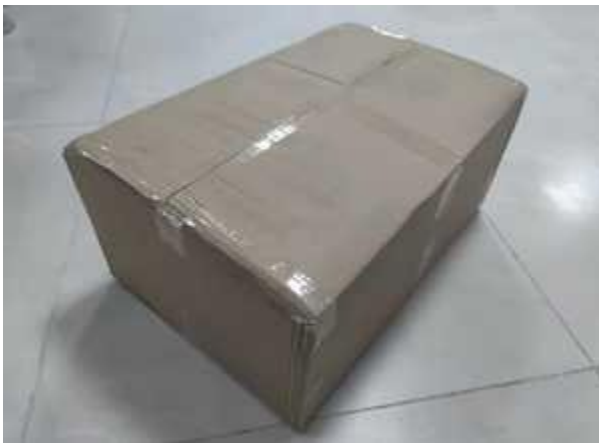
| Control | Requirement / plan | Observed | Decision |
|---|---|---|---|
| Master-carton mark | Required shipping identification | No mark observed | FAIL |

| Packing level | Observed configuration | Assessment |
|---|---|---|
| Shipping mark | No mark observed on outer case | FAIL |

**P-119** Outer master carton without shipping mark  
*Original source report page 26 of 26*

Do not authorize shipment until defective pieces are segregated, carton marking is corrected, accessory packing is reconciled and reinspection evidence is accepted.

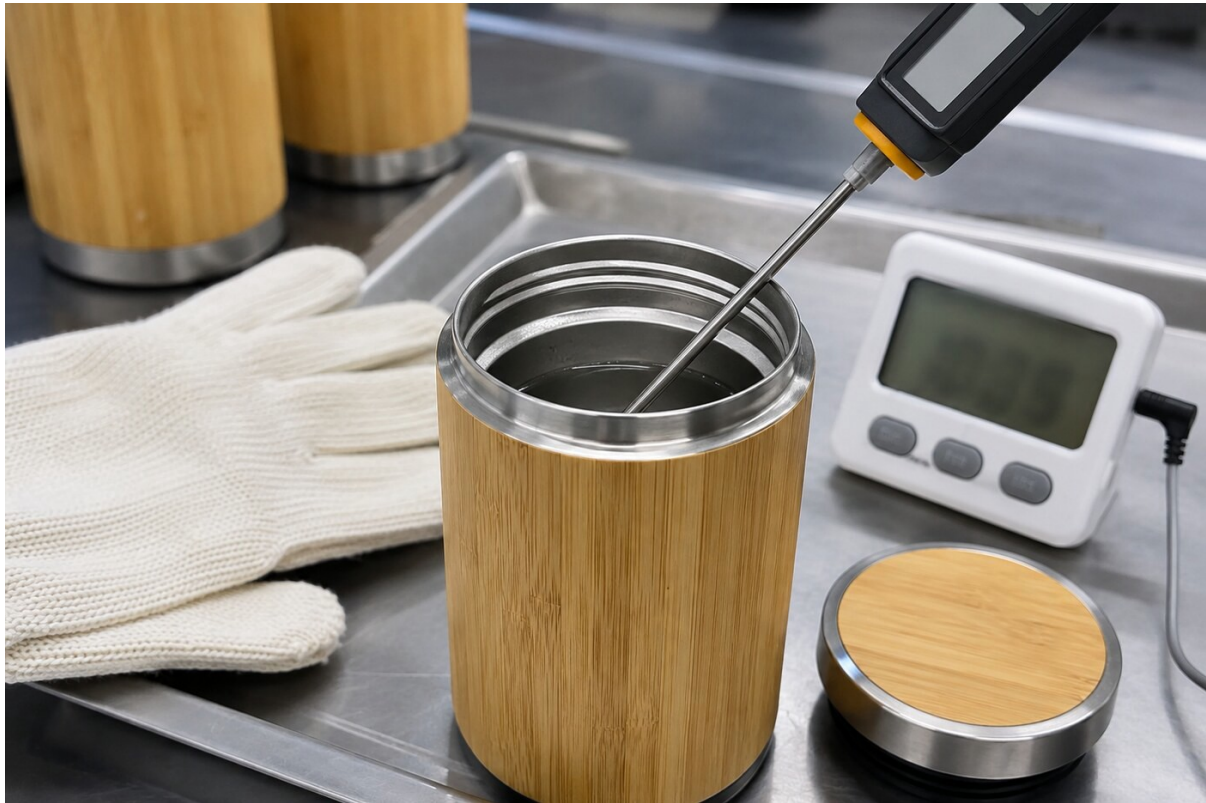
S-003 | ILLUSTRATIVE SUPPLEMENTARY IMAGE

**Illustrative method:** record ambient conditions, initial water temperature, elapsed time and each unit's final temperature.

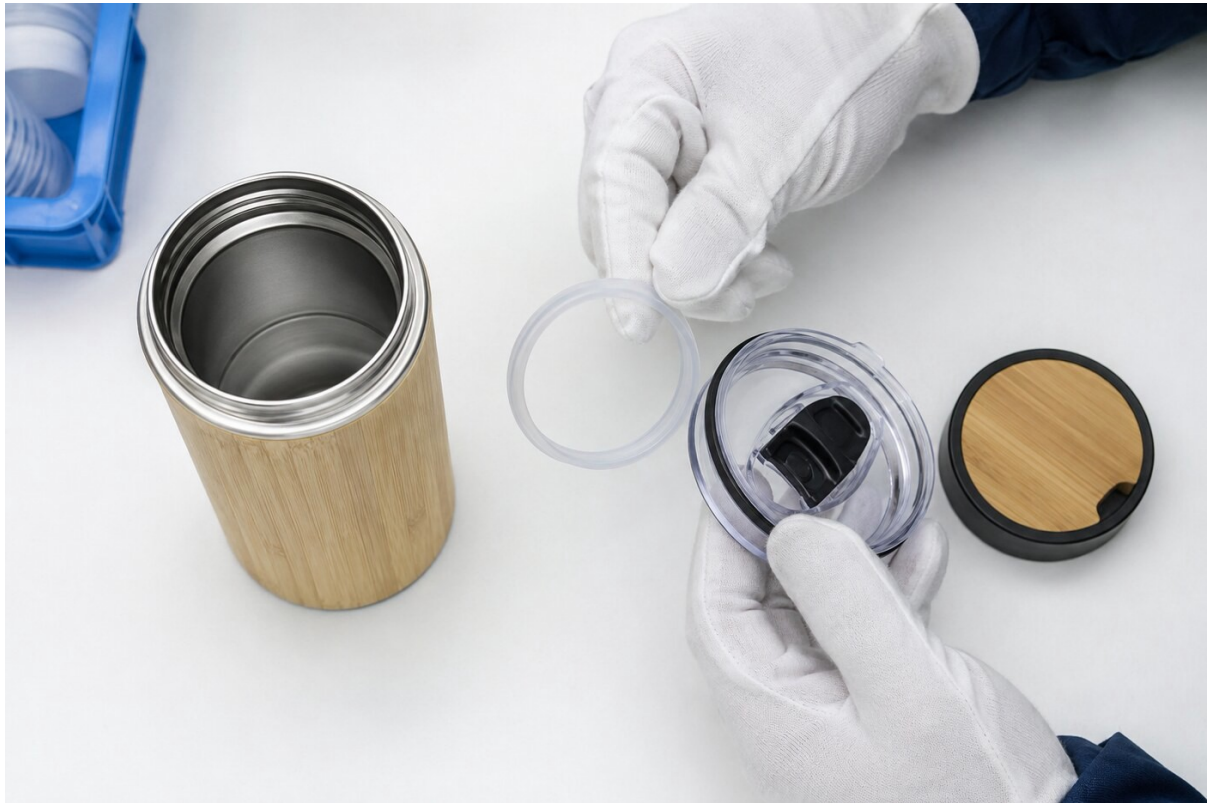
S-004 | ILLUSTRATIVE SUPPLEMENTARY IMAGE

**Illustrative method:** remove, identify, inspect and reseal the gasket before repeating closure and leakage tests.

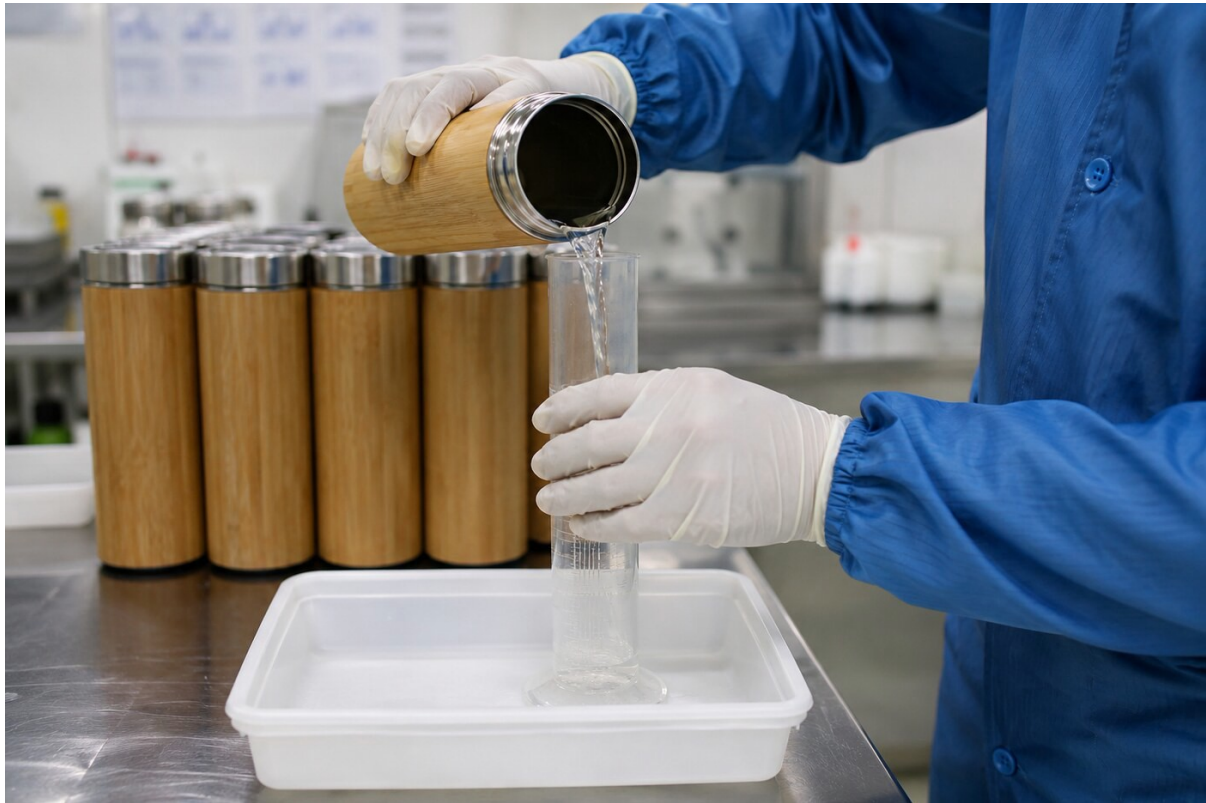
S-006 | ILLUSTRATIVE SUPPLEMENTARY IMAGE

**Illustrative method:** use a verified graduated vessel and a defined usable fill line, then record unit-level readings.
